Application Note 51625
(Revision -, 4/2020)
Original Instructions

RVP-200

Preserving Factory Calibration during Installation

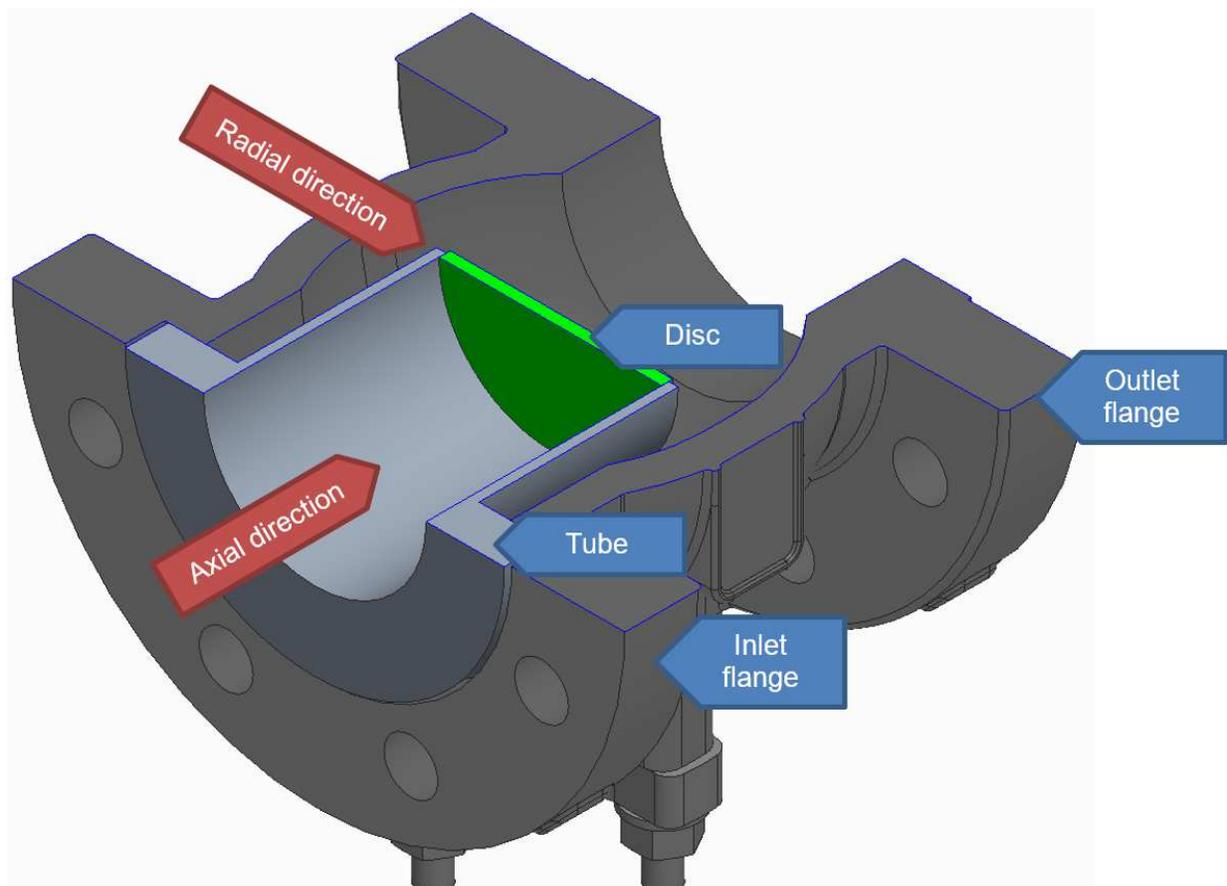
The valve trim consists of a factory aligned tube and disc. Any non-axial loads during pipeline installation can cause radial misalignment between the disc and tube. This causes poor seating of the disc, and can damage the edge of the disc, both of which result in rapid wear, increased friction, position errors, and/or excessive seat leakage. Figure 1 shows a simplified partial section with the affected components identified, as well as directional definitions.

Figure 1. Partial Section of RVP-200 with housing orientation and valve trim identified

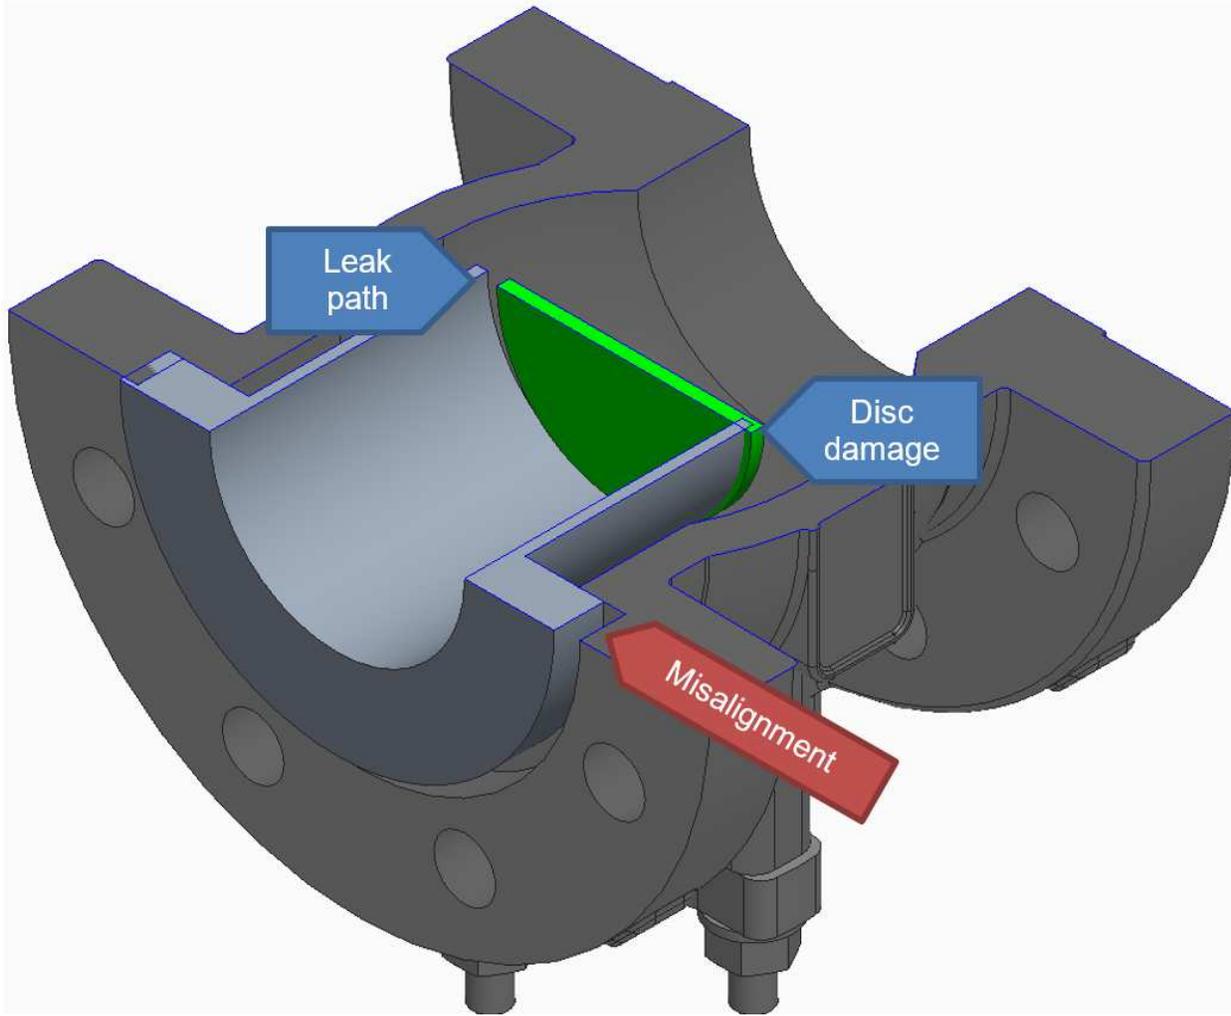
Figure 2 shows an exaggerated example of how misalignment causes damage. As little as .002 inches (.051 mm) can result in performance degradation.

Figure 2. Partial section showing exaggerated misalignment and resulting performance degradation

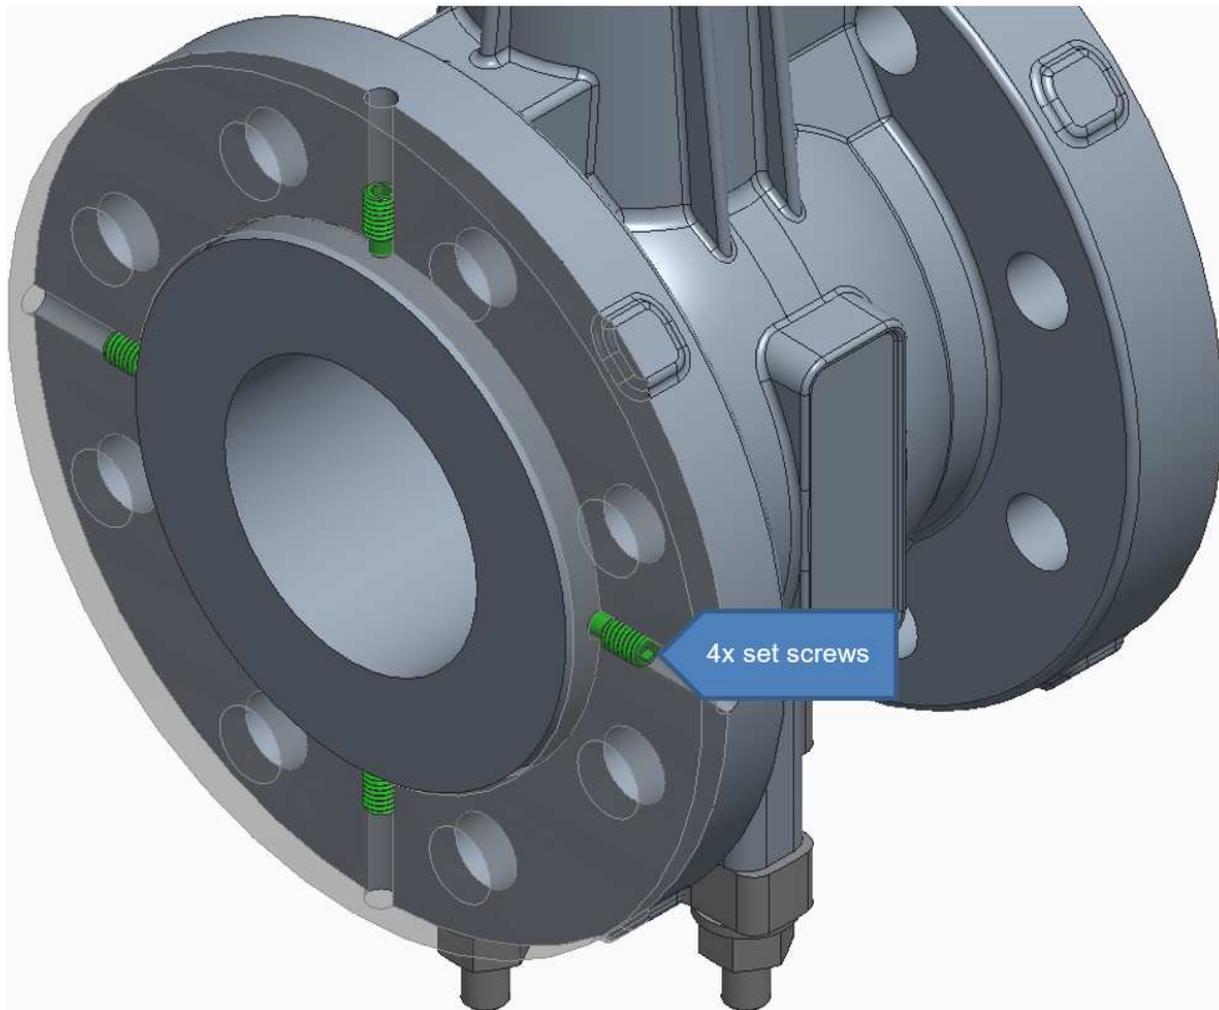
Figure 3. Partially transparent view of updated design showing set screws that provide greater alignment stability

The updated design adds four (4) set screws around the tube that restrain the position of the sleeve as illustrated in Figure 3. Do not attempt to adjust these factory calibrated screws. Adjusting the screws reduces their effectiveness and can damage the valve trim.

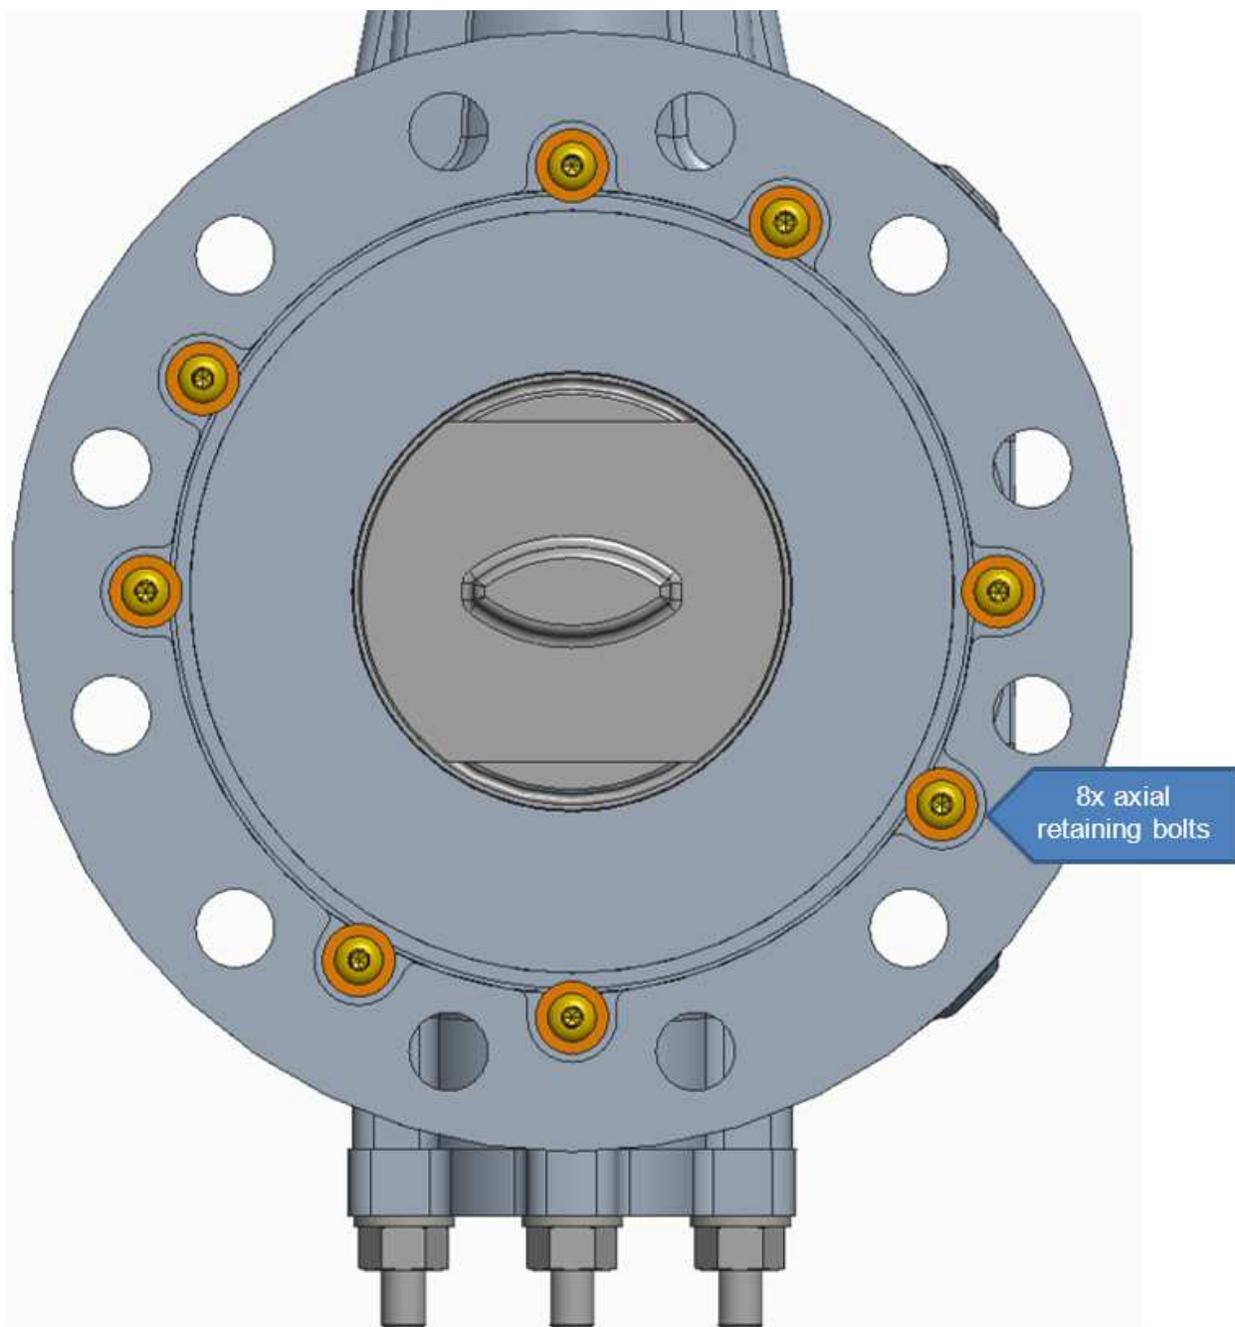
Figure 4. Six-inch valve with additional axial retaining bolts

Six-inch flange size valves also have an additional retaining feature added. Previous designs used four bolts mounted in the axial direction to retain the tube during installation. The updated design adds an additional four bolts (Figure 4) to further improve retention forces.
